# **Monthly Progress Report**

## **Amadablam Mini Hydro Subproject (911 kW)**

Khumbu Pasanglhamu Rural Municipality, Ward No. 4  
Solukhumbu, Nepal

**September 2025**

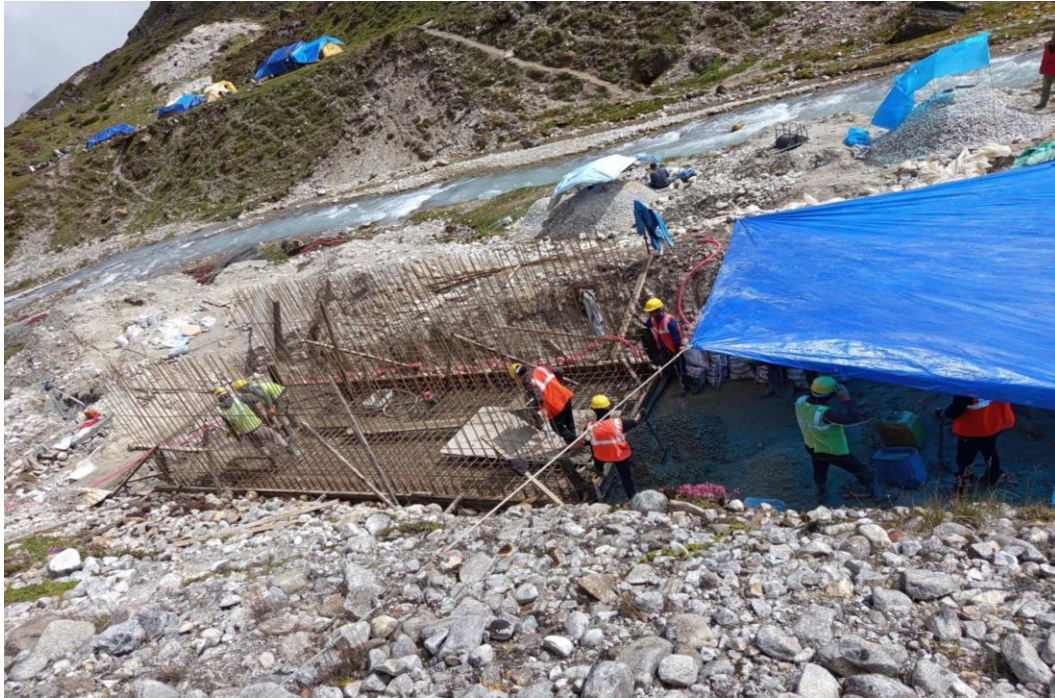
**Figure 1: Concreting works in desander basin (Panel 3 - Base)**

RCC works of the desander basin (Panel 1 with spillway) have been completed. RCC of Panel 3 base is finished, and rebar installation with formwork is ongoing for Panel 3 walls. Rebar works for Panel 2 have commenced. Masonry works for both the spillway canal and the desander flushing canal have also begun.

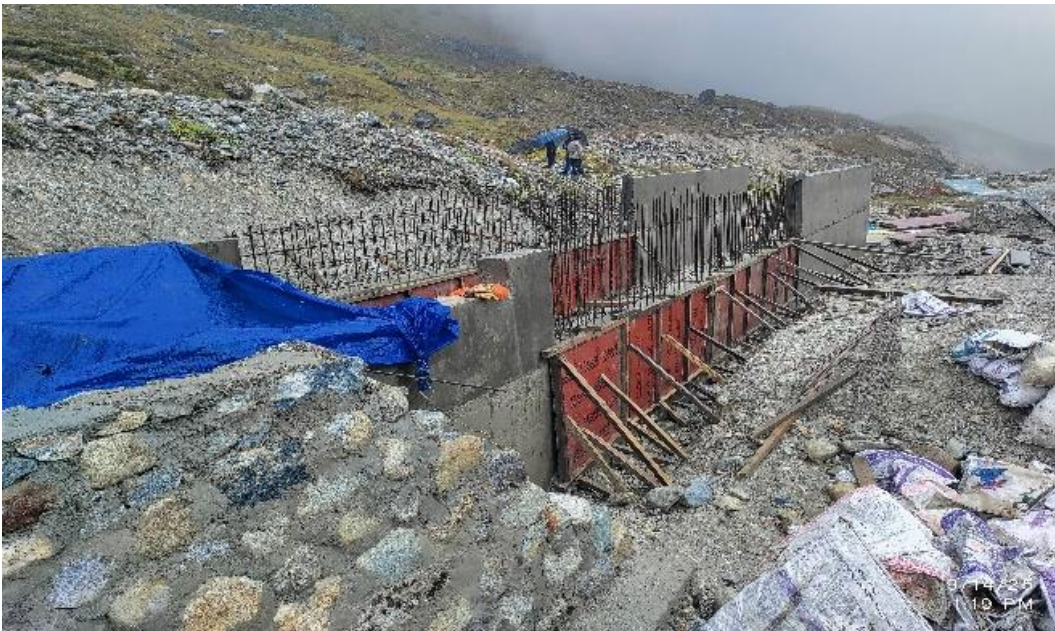
**Figure 2: Verge of completion of desander basin**

The inlet of the desander basin and the end section (head pond with flushing gate) are now ready for RCC base works. However, RCC walls can only be completed once the 10 m headrace pipe connecting the gravel trap to the bell mouth at the penstock inlet and the embedded parts for the flushing gates arrive on site.

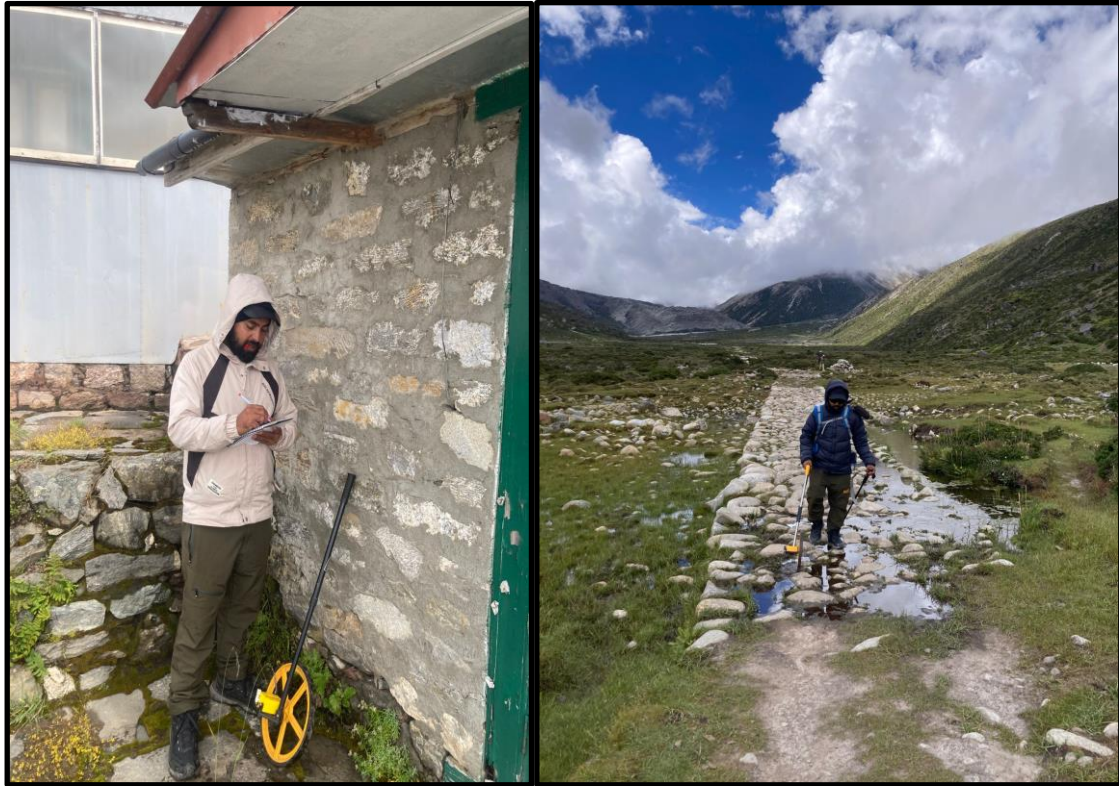
**Fig 3: GPS location and service wire length survey at Mong & transmission length verification from Pheriche to Lobuche**

During this month, a joint site verification was conducted with the contractor's engineer, covering the distribution box and transformer locations, which had not been properly specified in the initial report. The transmission and distribution cable lengths were also verified, where variations were identified. These details will be jointly presented in the site verification report, scheduled for submission to AEPC by 26 September 2025. Regarding Mingbo distribution plan, after site surveying, measurement of distribution cable length, service wire length, the final Mingbo distribution plan was submitted to AEPC on 24th of September. On 16 September, a joint team including the civil engineer visited the powerhouse site to conduct the Earth Resistance Test, required for the design and manufacturing of the grounding mat. The test was successfully completed, and the report has been submitted to the Project Manager for further processing.

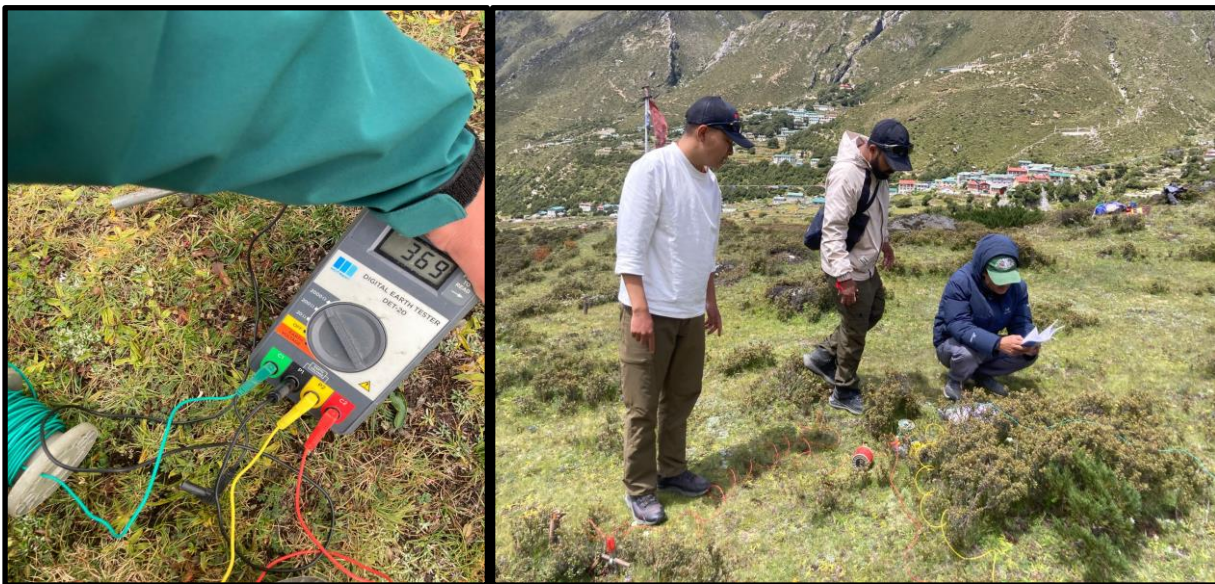
**Figure 4: ERT at Power house location to test soil resistivity of Power house area**

In addition, the site team's Civil Engineer and Electrical Engineer recently conducted a soil resistivity test, which had been overlooked during the DFS-DED stage for the powerhouse. The results of this test will be forwarded to the Consultant for the design and fabrication of the earthing mat. This proactive step will ensure that the earthing system is finalized and implemented in a timely manner, thereby avoiding further delays during the construction phase.

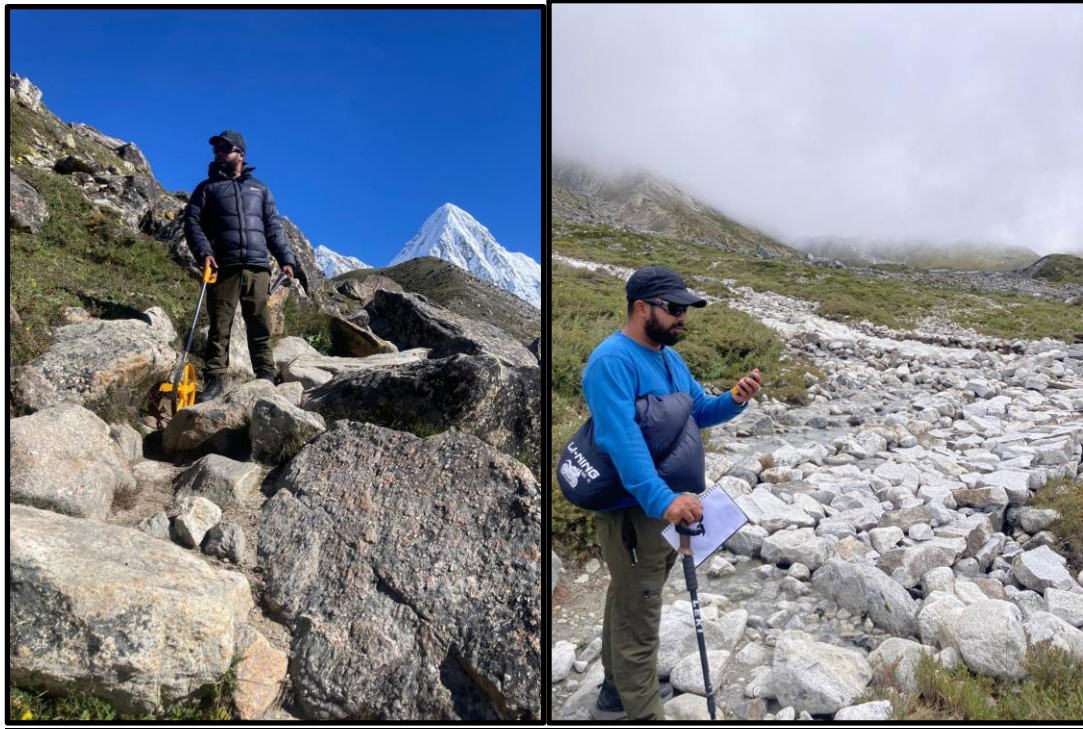
**Fig 5: Distribution cable length verification Pyramid Lobuche & locating crossing at Chukkung**

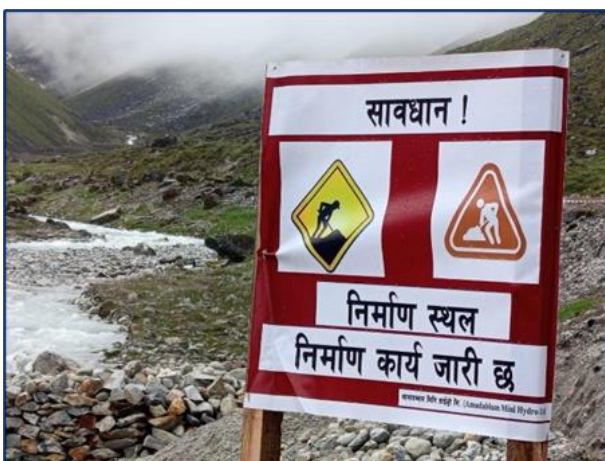
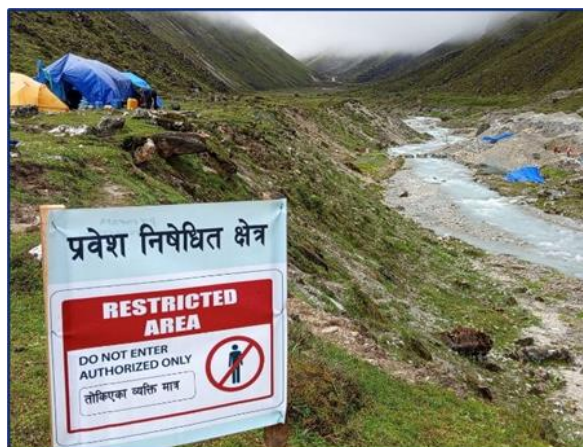
**Figure: Existing Construction Signages**

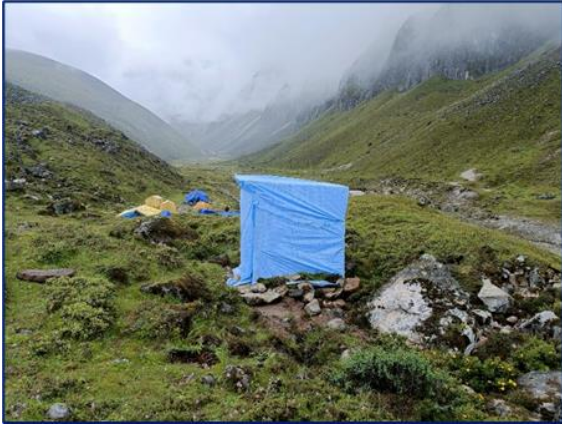
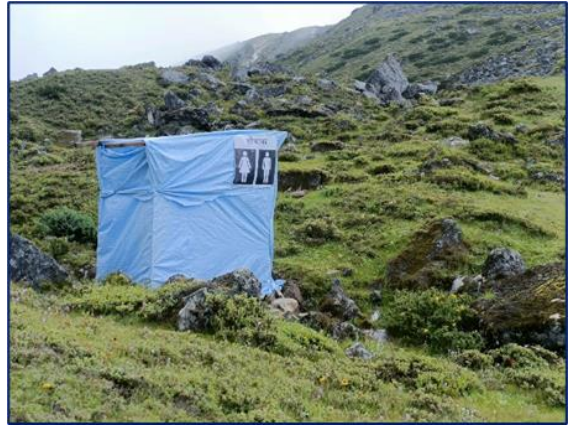
**Figure: Toilet near the labor camp**
