Monthly Progress Report

Amadablam Mini Hydro Subproject (911 kW)

Khumbu Pasanglhamu Rural Municipality, Ward No. 4
Solukhumbu, Nepal

October 2025

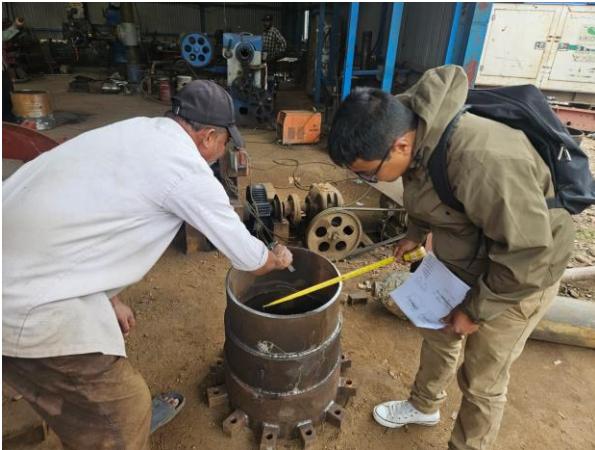
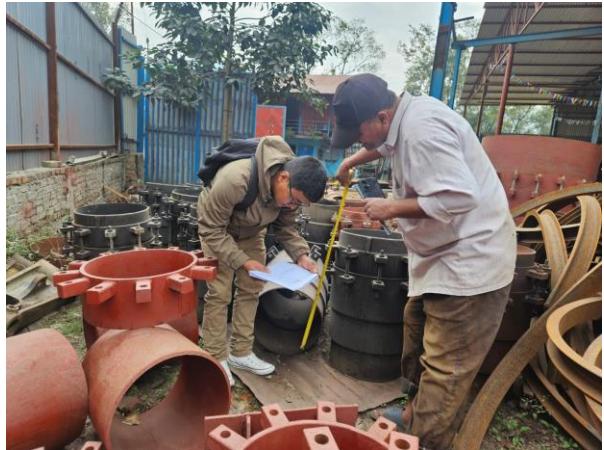
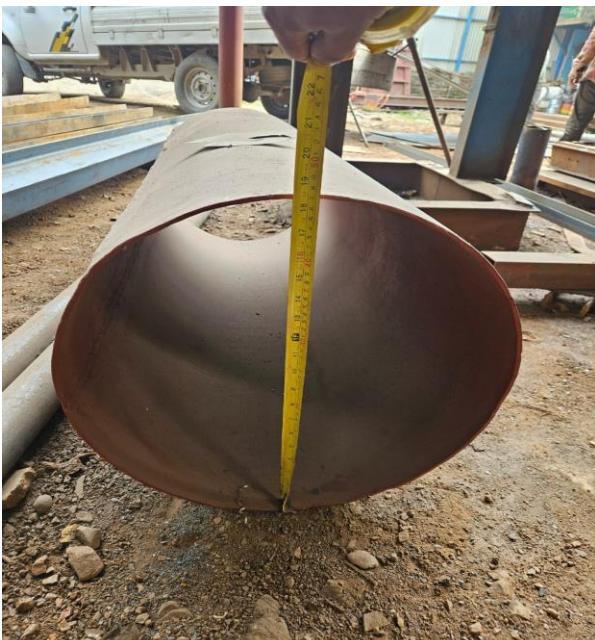
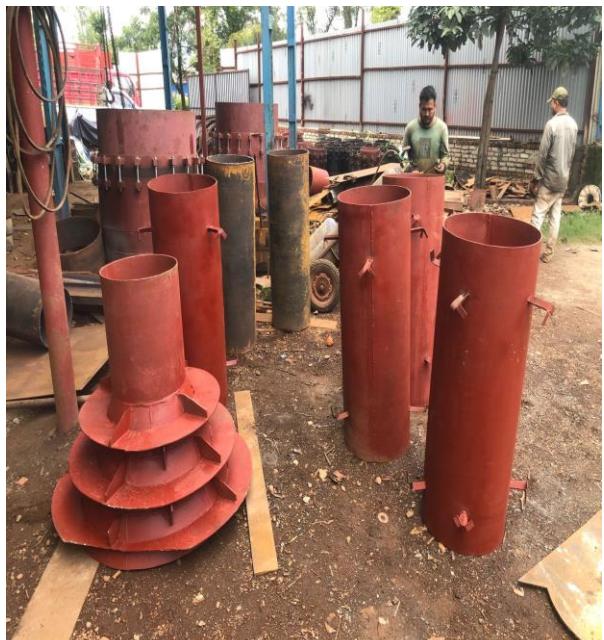
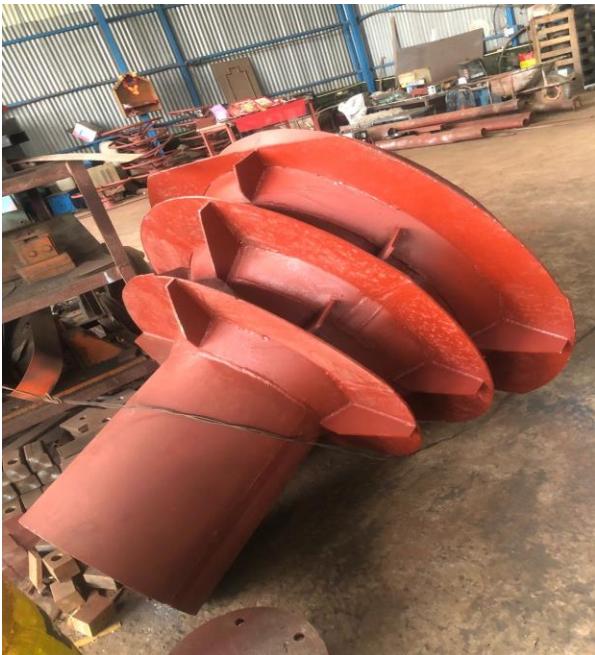
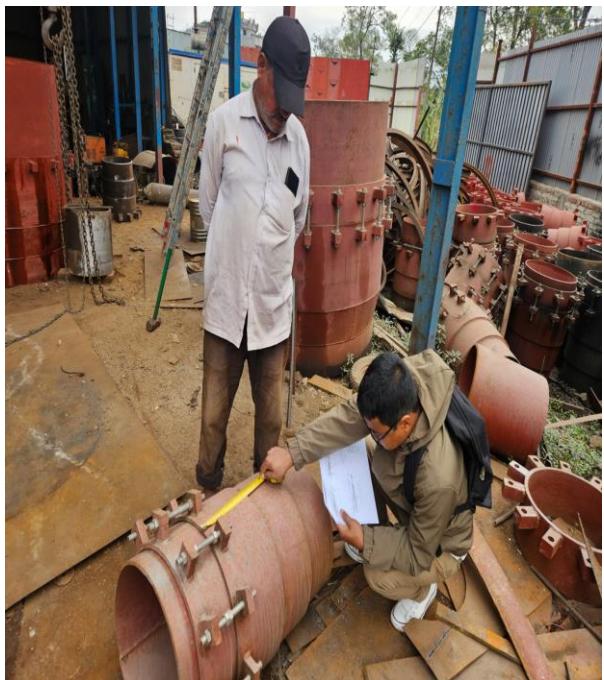
The Hydro-Mechanical (HM) contractor has completed the fabrication works of the headrace pipe, bell mouth, and expansion joints. A factory inspection of these components was conducted on 29th October 2025 in the presence of the Amadablam Mini Hydro Limited (AMHL) team, comprising the Mechanical Engineer and Civil Engineer, along with representatives from the HM contractor. The fabricated components have been verified and are now ready for transportation to the project site.

Factory Inspection of HM equipment

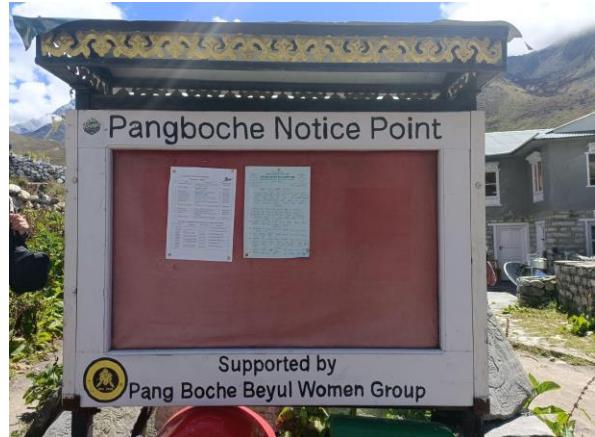
Figure: The AMHL project's emergency and suggestion numbers with contact details of responsible personnel are displayed on the information board.

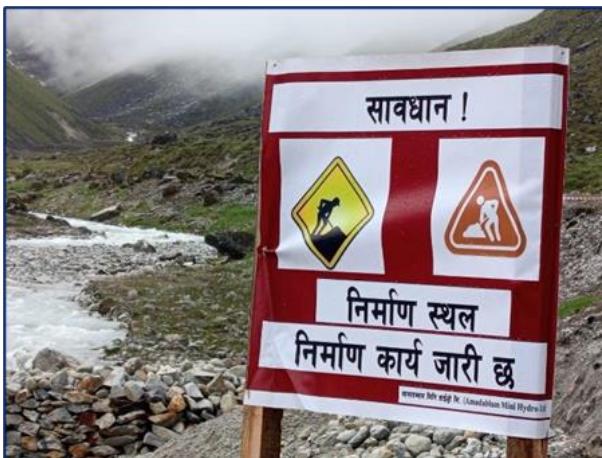
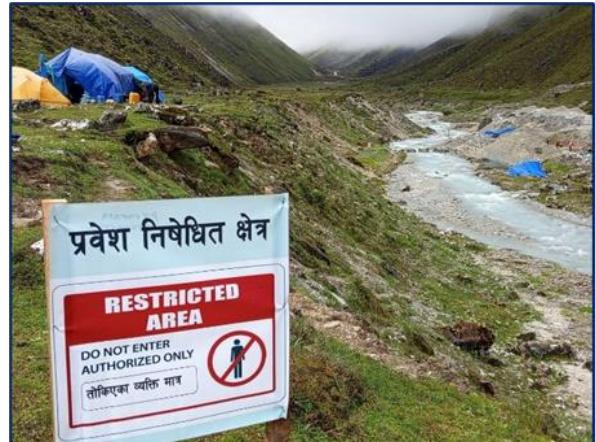
Figure: Existing Construction Signages

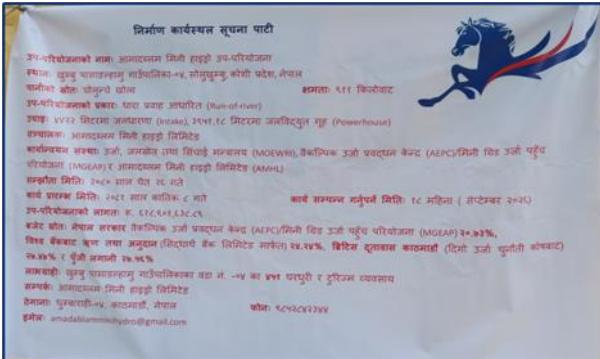
The project information board has been installed at the construction site in a clearly visible location. It provides clear details about the project, including its duration, budget, donor, and other relevant information.

Figure: Project information board at construction site

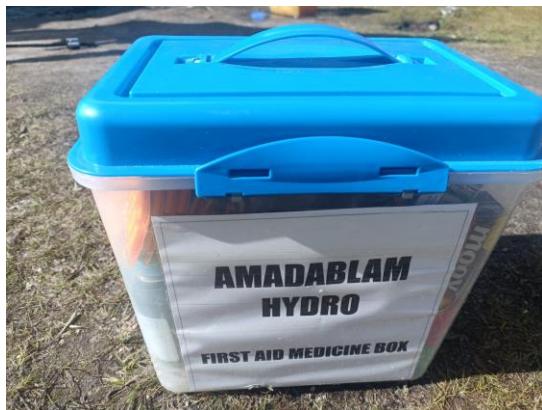
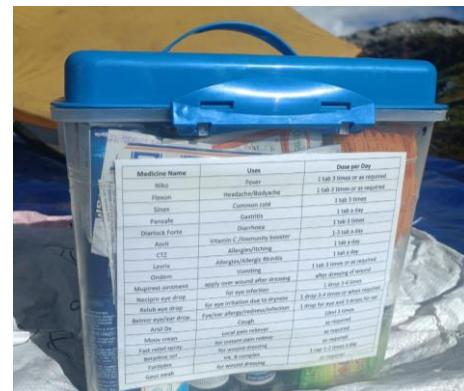
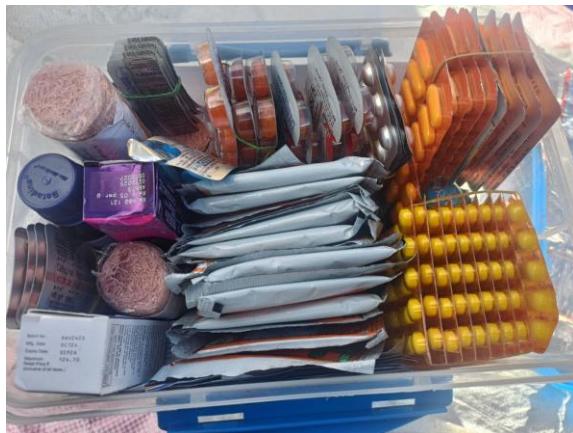
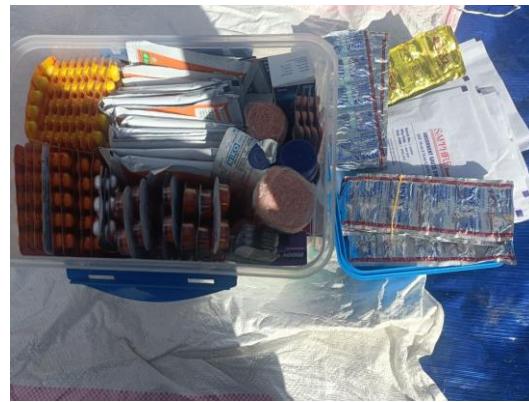
Figure: First aid box at construction site
