Monthly Progress Report

Amadablam Mini Hydro Subproject (911 kW)

Khumbu Pasanglhamu Rural Municipality, Ward No. 4
Solukhumbu, Nepal

November 2025

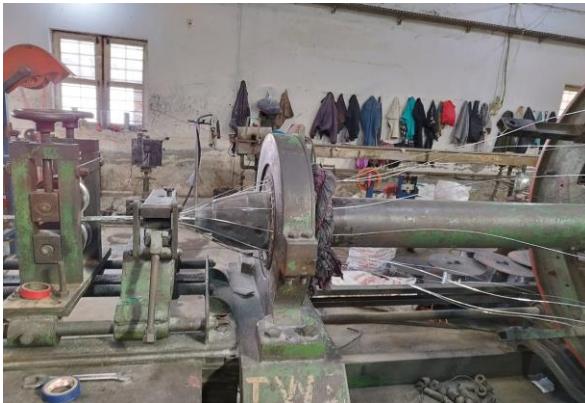
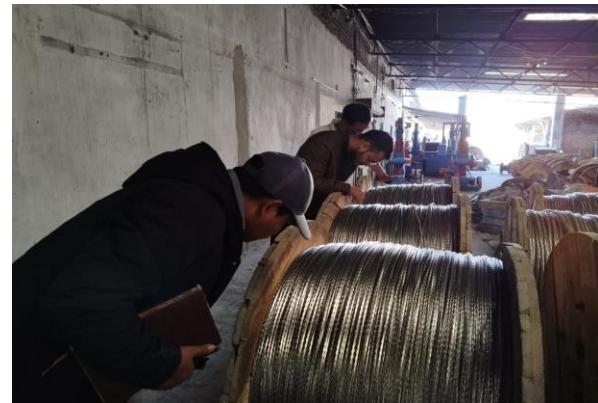
Fig 1. Factory Visit of LT cable at Janta Cable Industries Pvt. Ltd., Khanar, Itahari

With this, a meeting was held on 18th of November 2025 at Contractor office, a joint factory visit was planned and held on 20th November at Janta Cable Industries Pvt. Ltd., Khanar, Itahari. During the visit, Quality-in-Charge Er. Pankaj Yadhav of JCI, guided through the manufacturing process of the provided Low Tension Cable and provided the status of the manufactured cable. Likewise, the decision of completion of the remaining cable was due on 3th of December 2025 and a joint factory testing of the cable is planned for 5th - 7th December 2025. Also, on the go, the factory visit team visited Priyanka Metal and Pipe Industry on 22nd November 2025 where pole manufacturing and galvanizing process were studied and the contractor has been in contact with several pole and accessories vendors whose specification will be provided for approval by 15th of December.

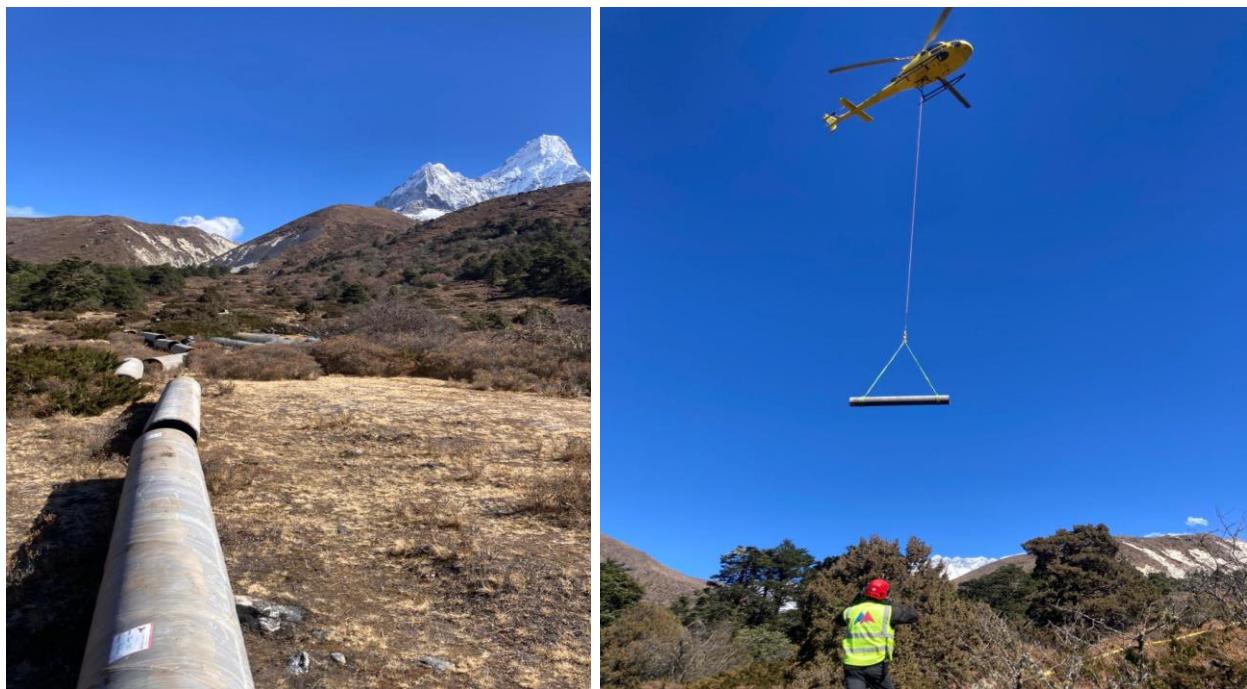
Fig 5. Penstock transportation and alignment at the project site by helicopter

This month marks a significant milestone for the Hydro-Mechanical (HM) contractor, as the transportation and airlifting of penstock pipes to the project site has formally commenced. Pipe movement from the maximum roadhead access point at Surke began on 6th November 2025.

As of the reporting date, 28th November 2025, a total of 351 penstock pipes have been successfully airlifted to the project site. The breakdown of the transported pipes is as follows:

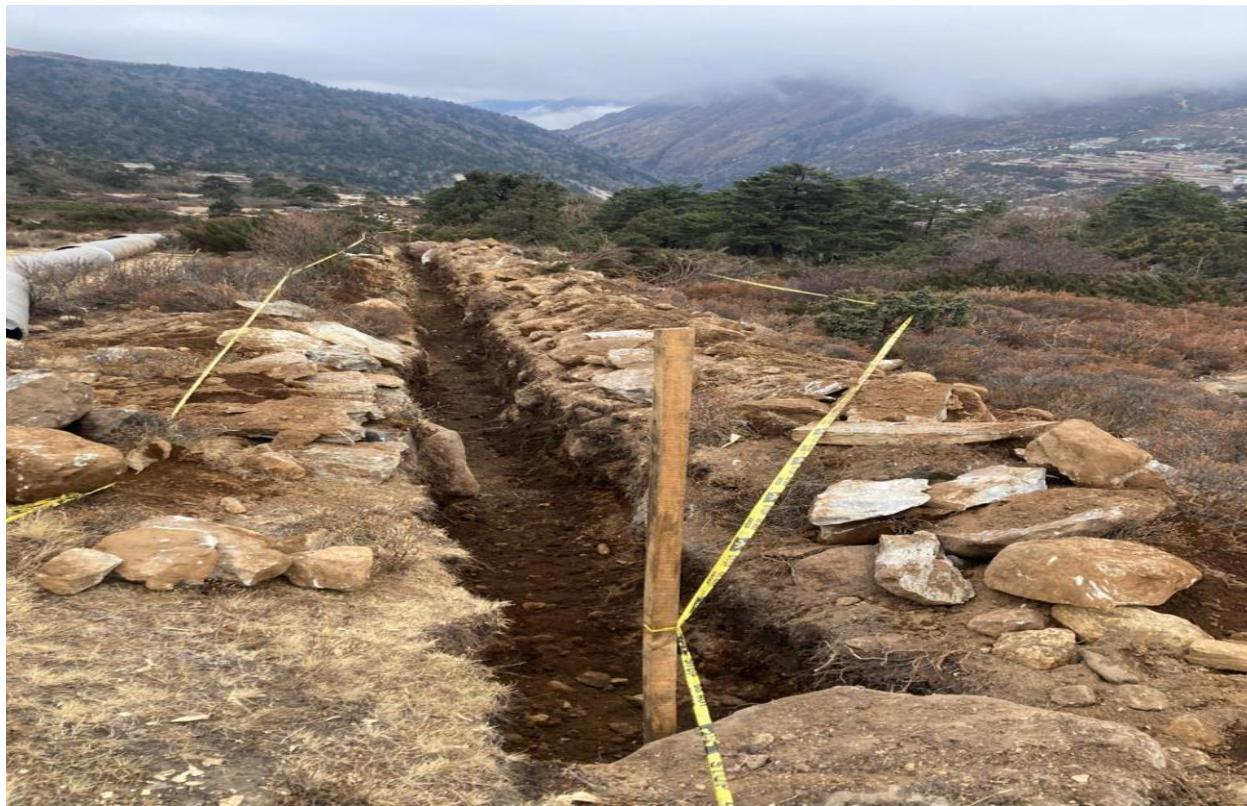
Fig 6. Trench formation for penstock pipe alignment

Excavation works for the penstock alignment have commenced in coordination with the Hydro-Mechanical (HM) contractor. Excavation up to chainage 0+500 at a depth of 0.7 m has been completed, including 12 anchor blocks. Excavation from chainage 2+800 to 2+400 is ongoing at a depth of 1.0 m.

The civil contractor has continued excavation of the powerhouse and the trench works in the powerhouse area. To date, a total of 280 meters of trench excavation has been completed in the powerhouse area and 500m in the intake area. Excavation is progressing in alignment with the planned sequence, facilitating timely installation of penstock and associated structures once the HM components arrive on site.

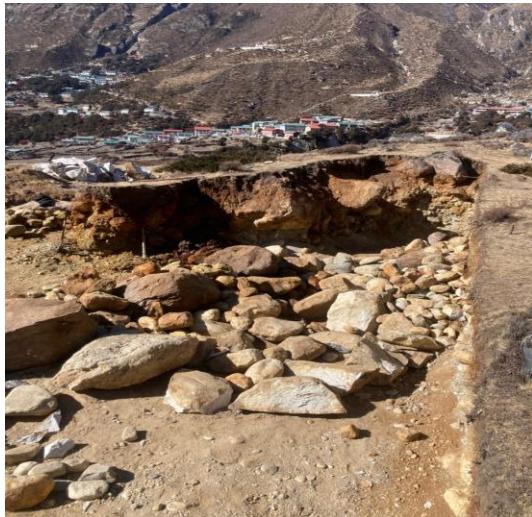
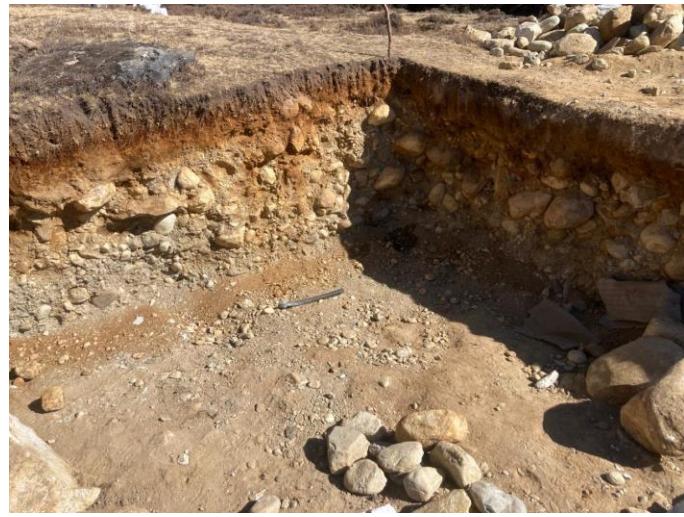
Fig 7. Excavation of Power house area

Excavation works at the powerhouse have commenced, and excavation has been carried out up to a depth of 1.5 m. The contract for the earthing mat design has been finalized, and the design work is expected to be completed within the first week of December. Immediately after the design is completed, procurement and delivery to the site will commence.

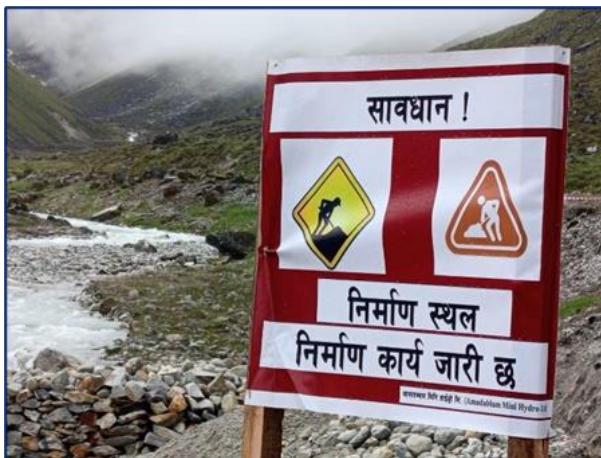
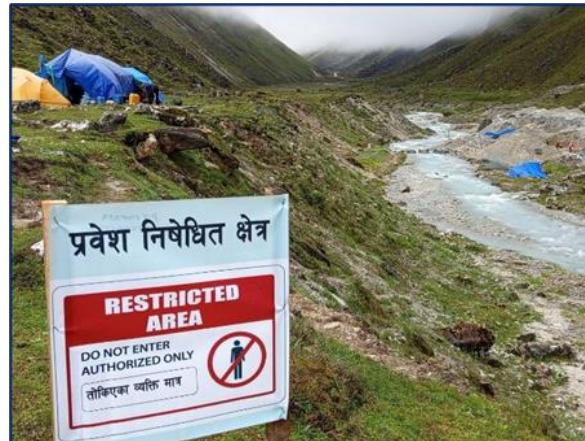
Figure: Existing Construction Signages

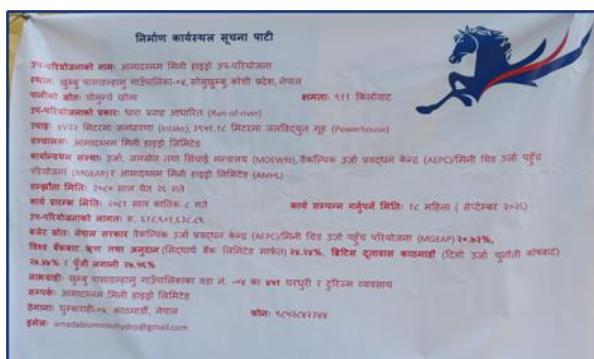
Figure: Project information board at construction site

The project information board has been installed at the construction site in a clearly visible location. It provides clear details about the project, including its duration, budget, donor, and other relevant information.

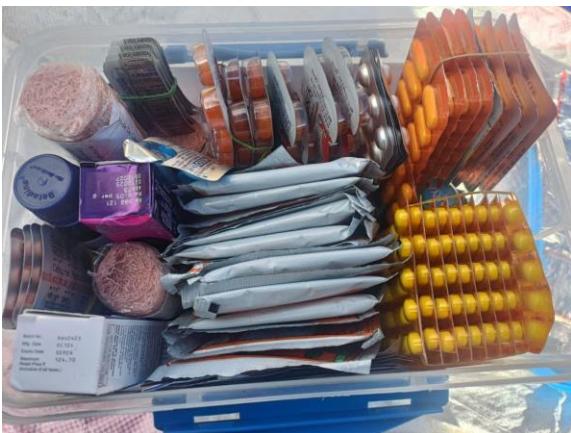
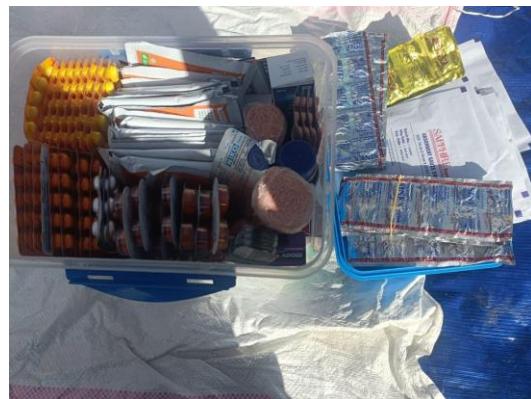
Figure: First aid box at construction site

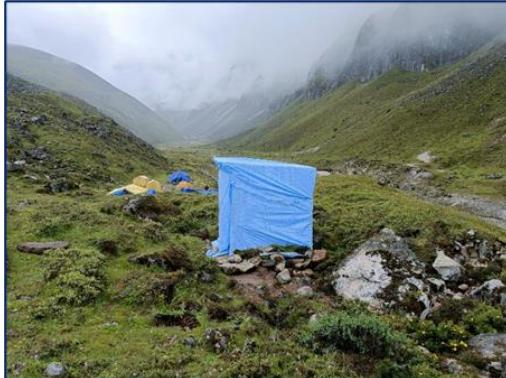
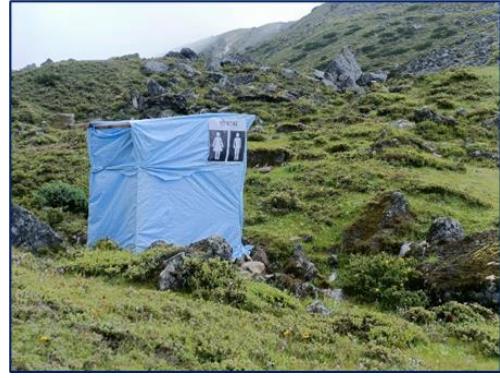
Figure: Toilet near the labor camp
